Upper Cliff Dwelling Floorplan (Numbered descriptions match room numbers on map)

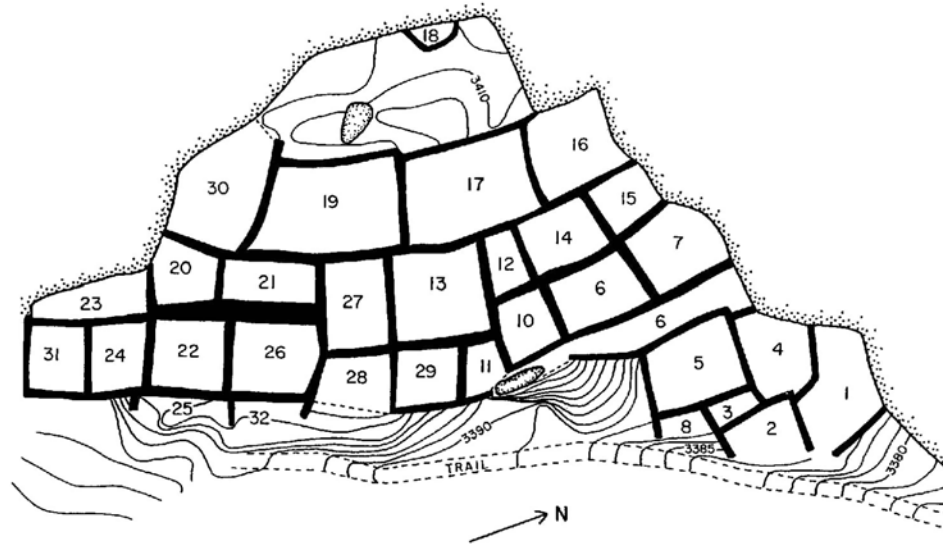
1. Work area and room under construction but never completed. Last room worked on.
2. Roof and portions of walls removed and room used as midden area. Found sherds, piles of mesquite beans, and lima bean pods. Two burials found in 1936 and 1940.

3. Probably never roofed. Small pit next to boulder. Both pit and floor area blackened.
4. Most complete roof. Note juniper and pinyon posts set in walls. Door into #5 blocked up. 18" of midden on west wall from #6. Posts above are split agave and sotol flower stalks, layers of cane and grasses, then layer of adobe.

5. Two story room, both ceilings burned and fell down. Ceiling in NW corner slopes towards front, and repairs were made to provide level floor for second story. Juniper log found in front of #5 tree-ring dated to AD 1346.

8. Small room, no work done.
16. Room totally excavated. Found pottery sherds, several fire pits. Pollen samplings from layers of fill revealed usage of plants which were no longer available as the resource was used up. Was two-story room.

17. One story, room had burned. Metate found on floor. Adobe cracked, probably because initially laid on soft fill.
18. Area used for water storage from seep above. Entire area surrounding it was common area, used for community work.

19. Largest room. When first visited (1920), room was sealed. Three doorways were blocked, roof was intact. When room was broken into, roof was carried away, burned, or destroyed. Archeologists found few artifacts, but some modern day trash.

20. Floors of #20 and #21 are 7' above that of #22. Floor of cave slopes steeply in this area; high retaining wall built so that level floor could be laid in rooms.

- 21.** Appears to have been 3-story room. West wall is only 2 stories, but east wall is continuation of 7' retaining wall of #20, above which the 2-story room was constructed.

- 22.** Three baskets found in room. Room exposed to erosion during rains by small waterfall from top of cliff.
- 23.** Perhaps used for storage, or as a midden (trash) area. Many sherds, basket fragments, some pieces of textiles found here.

- 24.** Exposed to rains, little remains. Most vegetal material rotted away.
- 25.** Only two short stubs of wall east of #22 remain. Everything else has washed down the hillside.

- 26.** Lots of fill, but no artifacts found.
- 30.** No evidence of any roofing materials, little fill on floor. No work done in this room.
- 31.** Rooms exposed to rain; received wash from cliffs above. Only one wall partially standing.

- 32.** Only two short stubs remain. No work done here. Probably most of room washed down hillside.
